1.0 INTRODUCTION

Pearl Lake, Waushara County, is a 101-acre seepage lake with a maximum depth of 45 feet (Figure 1.0-1). Curly-leaf pondweed (*Potamogeton crispus*, CLP) was first discovered in Pearl Lake in 1977 and Eurasian watermilfoil (*Myriophyllum spicatum*; EWM) in 1994. A hybrid variety of EWM and the native northern watermilfoil (*Myriophyllum sibiricum x spicatum*, HWM) was verified in 2022 in addition to confirmed pure strain (via genetics) in 2010. Unless otherwise specified, this report will refer to *EWM* as the collective population of invasive watermilfoil (EWM & HWM).

Map 1
 Pearl Lake
 Waushara County, Wisconsin
**September 2025 Acoustic
 Bathymetric Model**

Map 2
Pearl Lake
Waushara County, Wisconsin
2025 EWM
Survey Results
Early vs Late Season

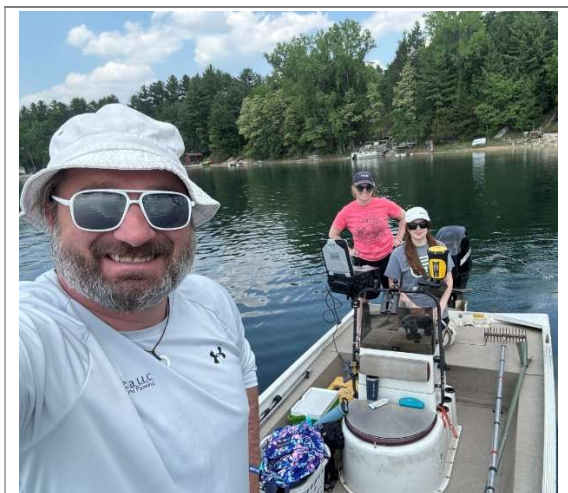
Photograph 1.1-1. Onterra crew during 2025 Early Season EWM Mapping Survey on Pearl Lake. Photo credit Onterra.

25). Onterra was contracted to complete the studies outlined, aimed at monitoring and planning the manual removal program during this 2-year project (Photograph 1.1-1). The results of the monitoring and management activities that occurred during 2025 along with a preliminary plan for 2026 are discussed within this first of two report deliverables for this grant-funded project.

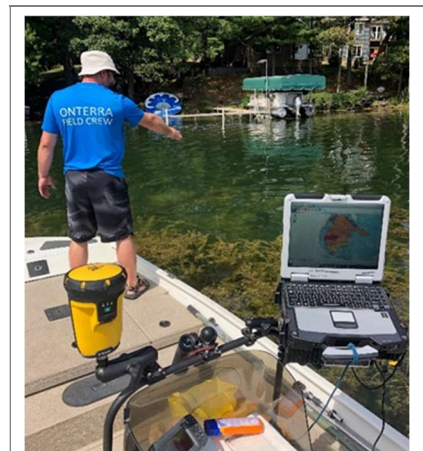
Photograph 2.0-1. EWM mapping survey on a Wisconsin Lake. Photo credit Onterra.

A pair of EWM mapping surveys (early-season and late-season) were used to coordinate and monitor the hand-harvesting efforts in Pearl Lake. During the EWM mapping survey, the entire littoral area of the lake is surveyed through visual observations from the boat (Photograph 2.0-1). The EWM population is mapped using sub-meter GPS technology by using either 1) point-based or 2) area-based methodologies. Large colonies >40 feet in diameter are mapped using polygons (areas) and are qualitatively attributed a density rating based upon a five-tiered scale from *highly scattered* to *surface matting*. Point-based techniques were applied to EWM locations that were considered as *small plant colonies* (<40 feet in diameter), *clumps of plants*, or *single or few plants*.

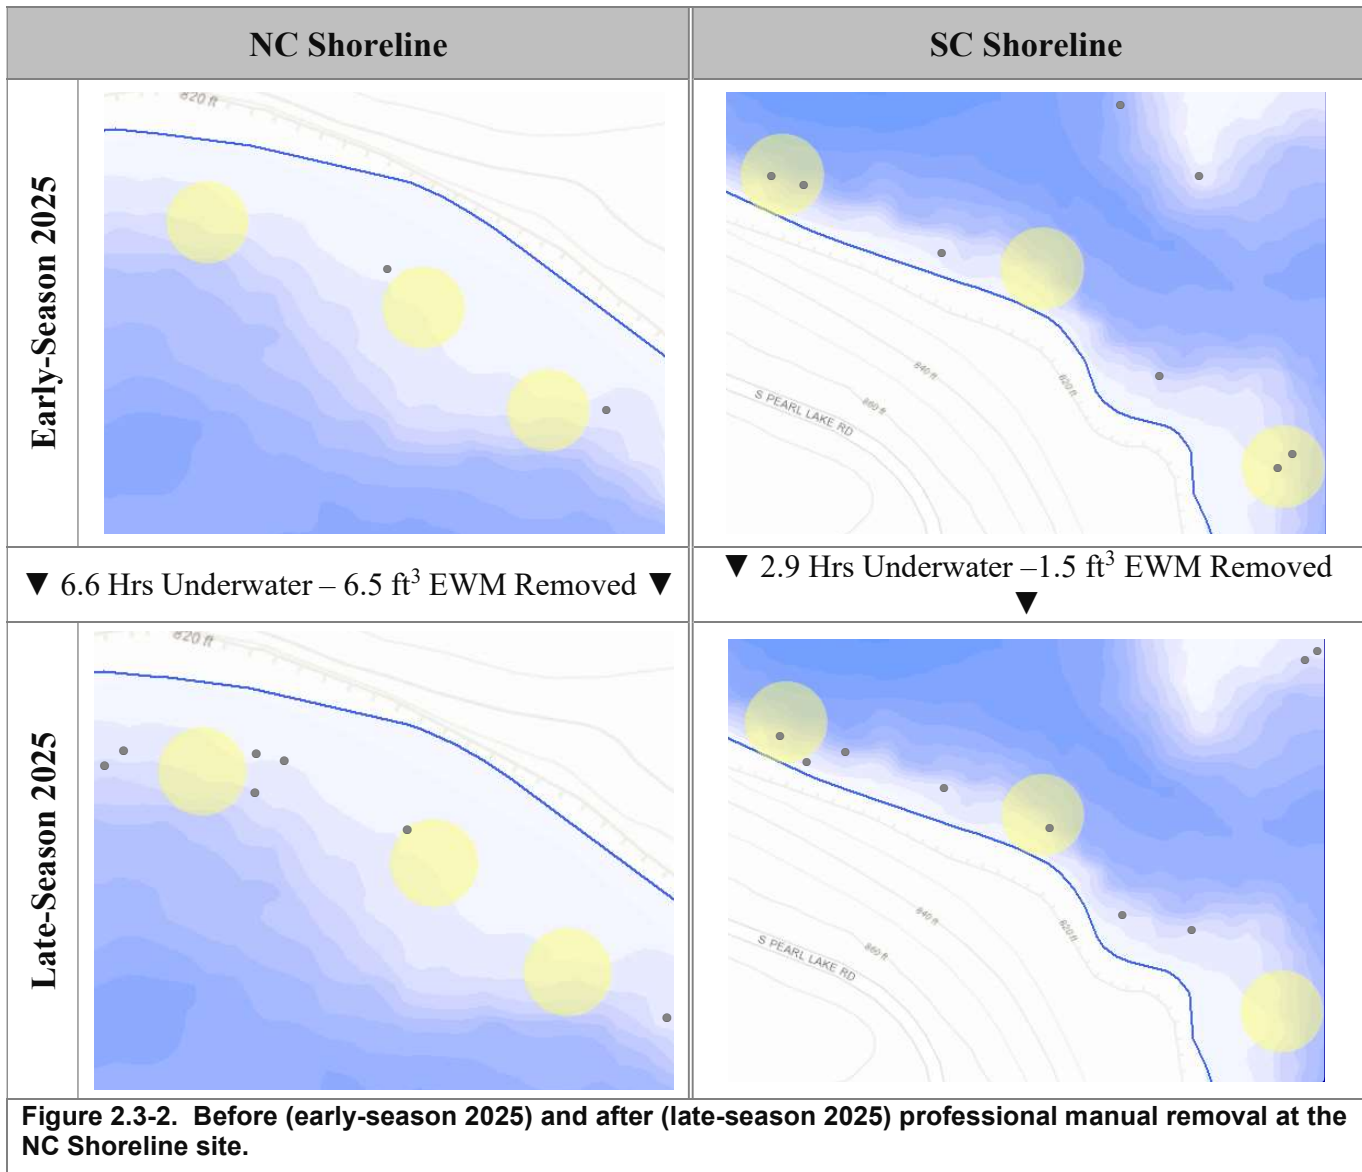
The next two most targeted manual removal areas in 2025 were the north central (NC) shoreline and south central (SC) shorelines sites (Figure 2.3-2). Please note that these figures differ from the previous, with the Early Season Survey from each site on top, and the Late-Season Survey on bottom. During the 2-25 Early Season EWM Mapping Survey, only loose occurrences of EWM were noted in these areas. As the summer progressed, more individual plants could be observed, likely through a combination of population expansion and plants that went undetected during the early season survey. The 2025 Late Season EWM Survey also noted individual plant occurrences in these sites, although slightly different locations.

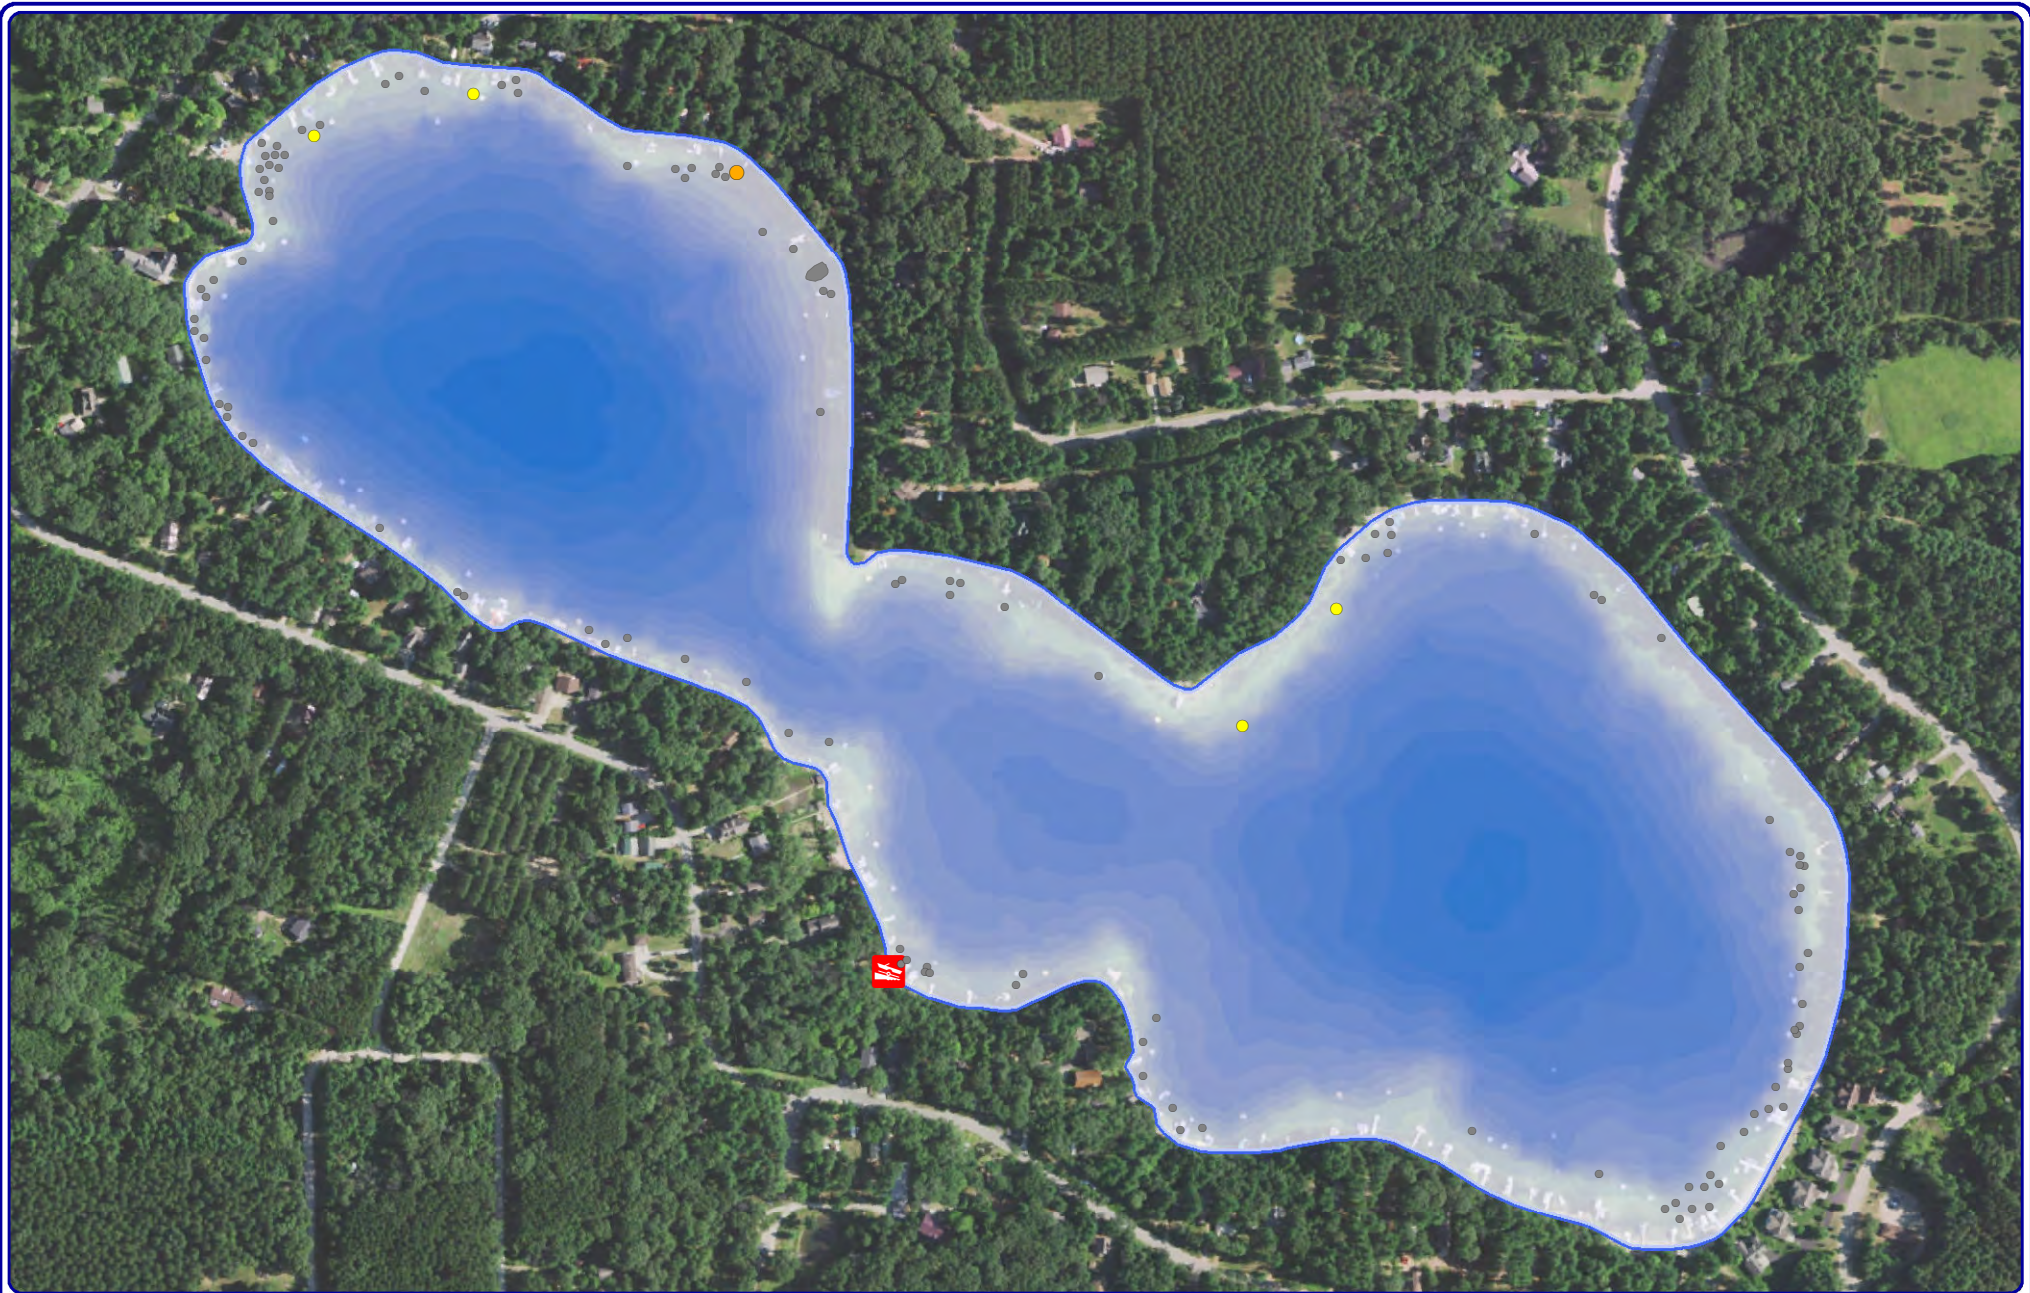
Map 3 (Overview Map)

The field crew mapped one small *scattered* polygon sized colony (<0.1 acre in size) and numerous point-based occurrences around the lake. The number of point-based occurrences was about double that documented during the early season survey, likely as a result of EWM population expansion and small-statured plants that escaped detection during the early season survey. Of the point-based occurrences, one was identified as a *small plant colony*, four points were identified as *clumps of plants*, and the remaining were *single or few plants*.

**Late-Season 2025
 EWM Survey Results**

The late-summer EWM mapping survey was conducted on September 12, 2026, to qualitatively assess the hand harvesting efforts as well as to understand the peak growth (peak-biomass) of the EWM population throughout the lake in 2025. Map 3 provides an overview map, with Maps 4 and 5 zooming in to each basin. Map 2 displays a comparison of the 2025 early season and late season EWM mapping surveys.

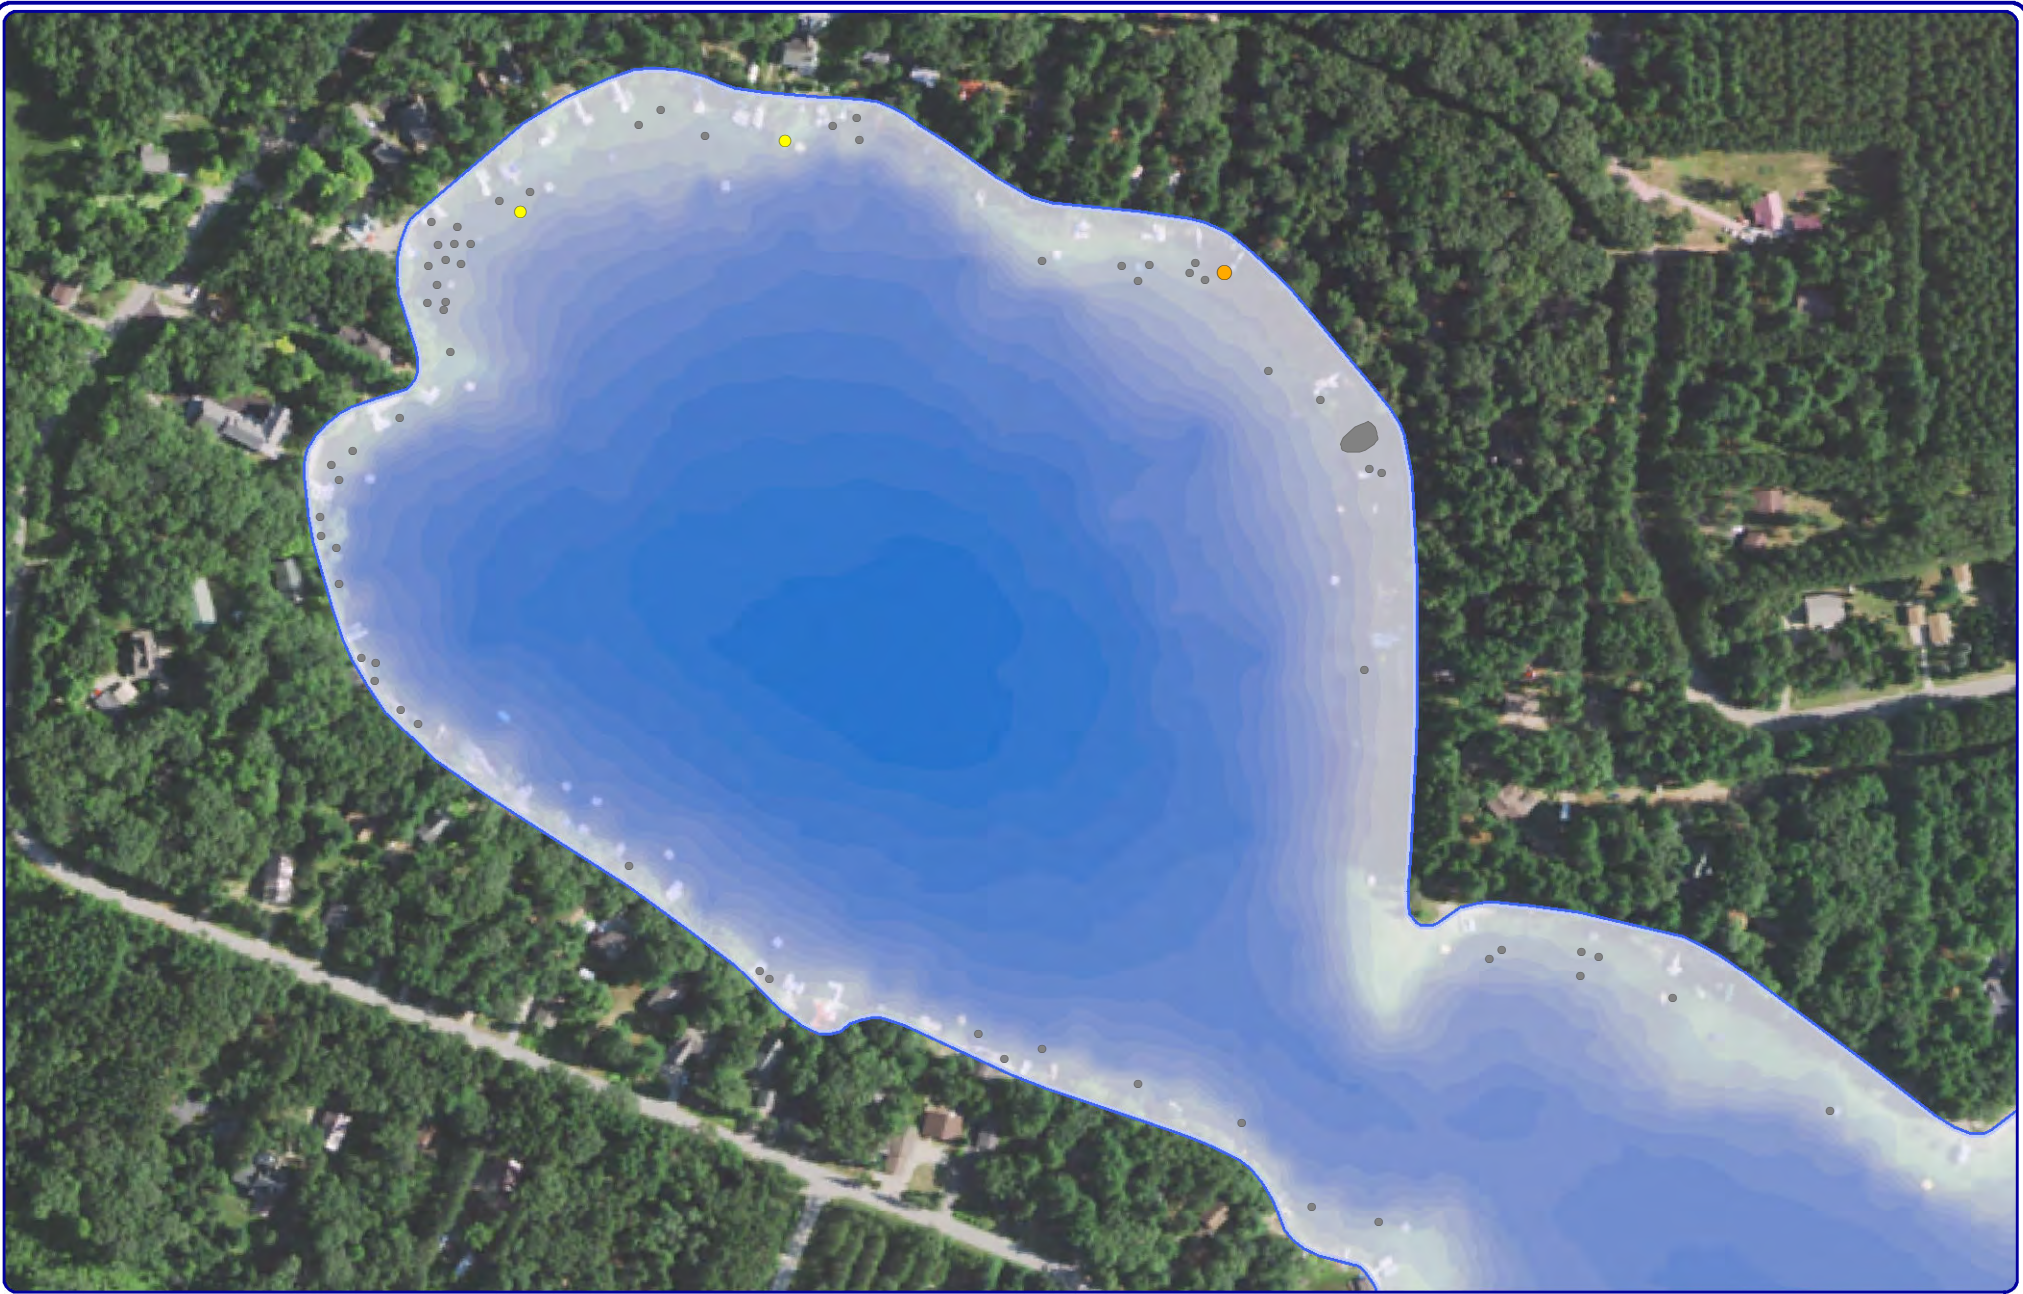
Map 4 (West Inset Map)

**Late-Season 2025
 EWM Survey Results**

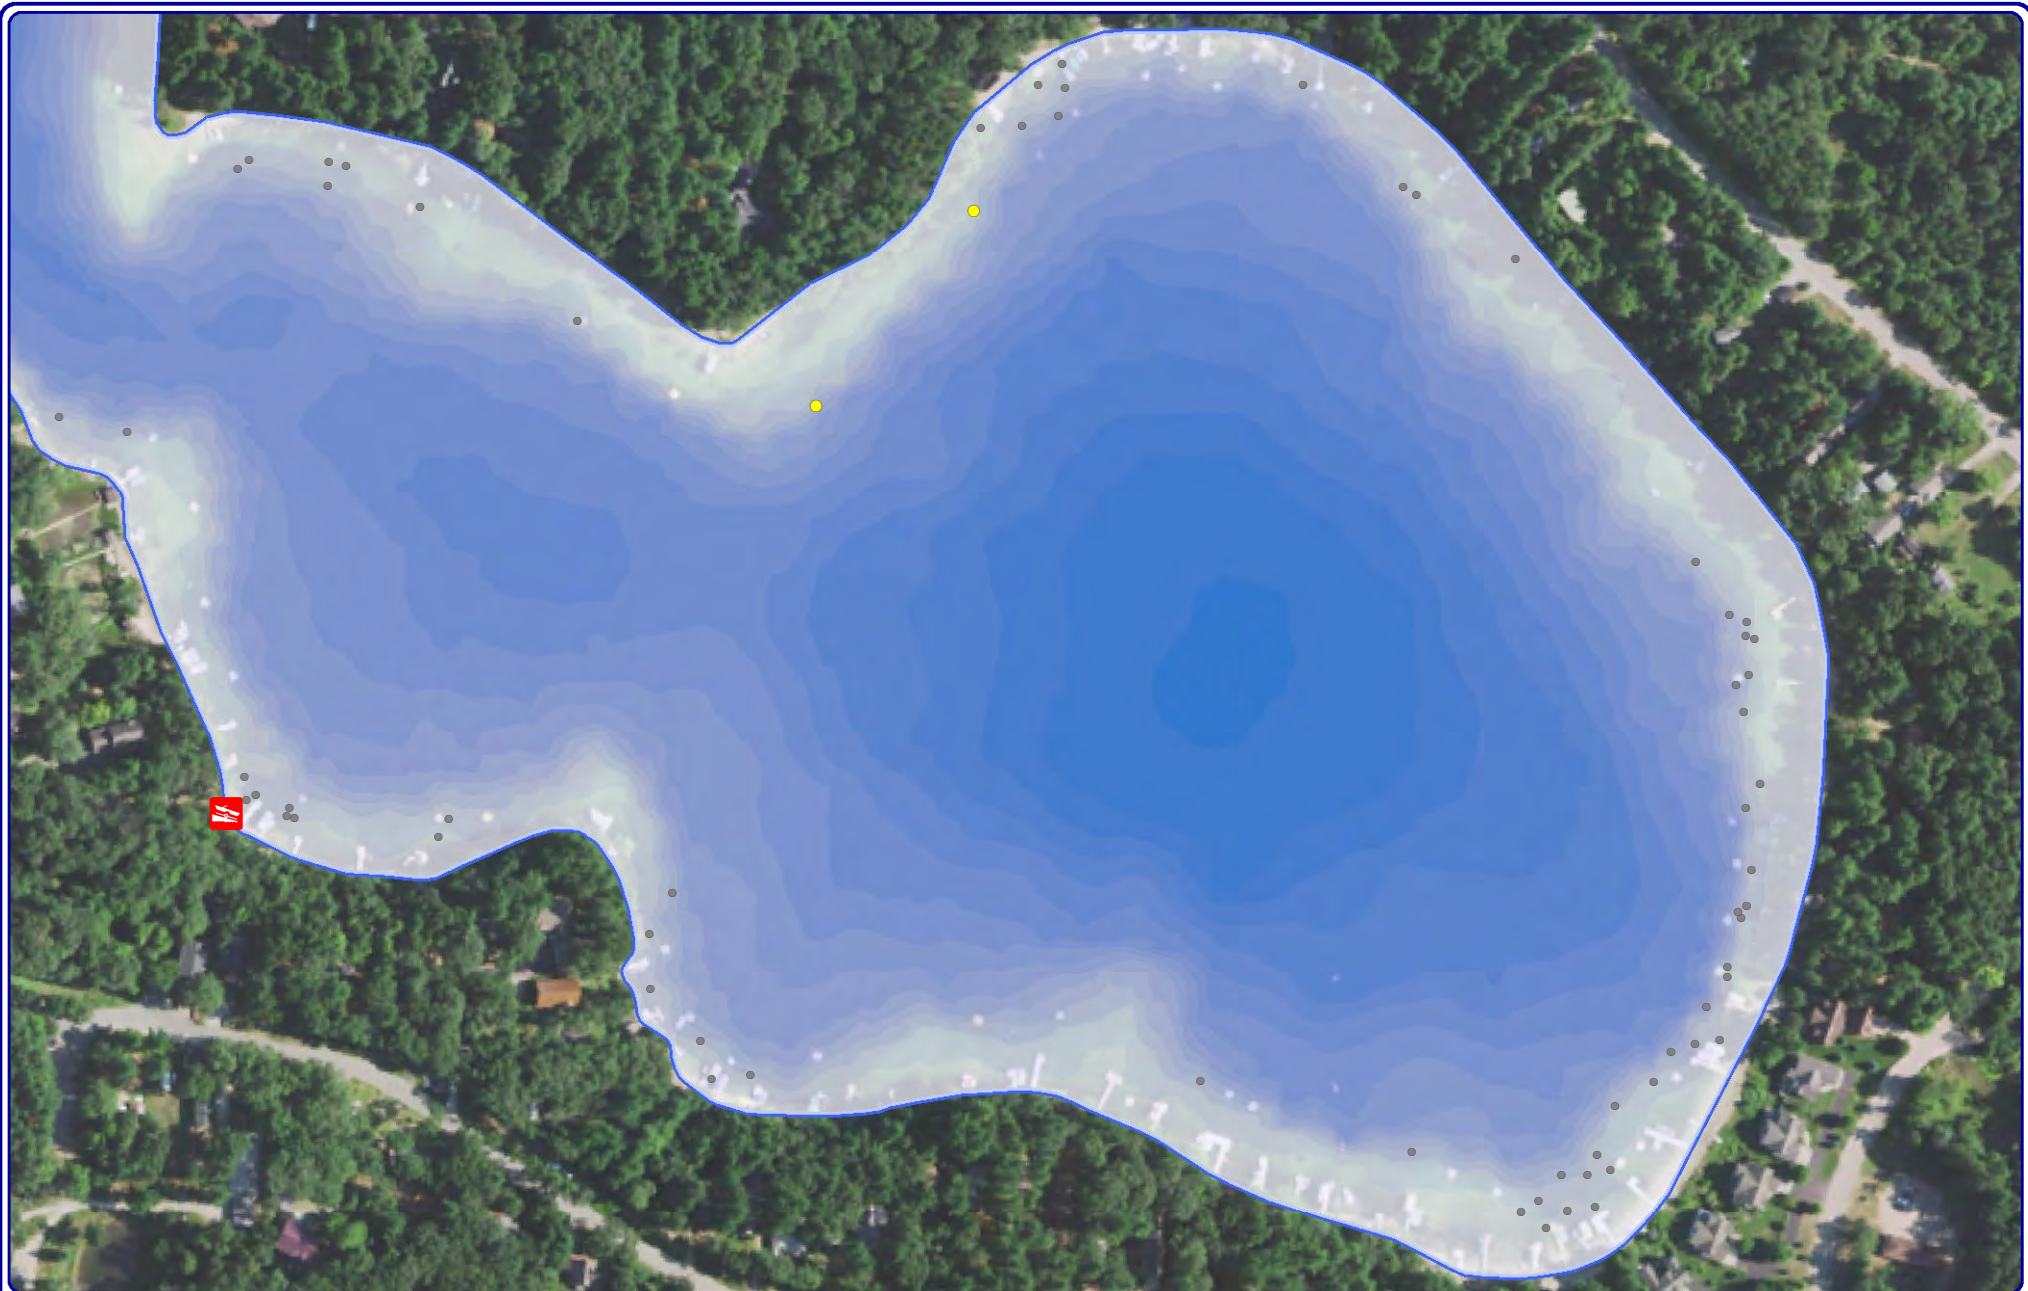
Map 5 (East Inset Map)

**Late-Season 2025
 EWM Survey Results**

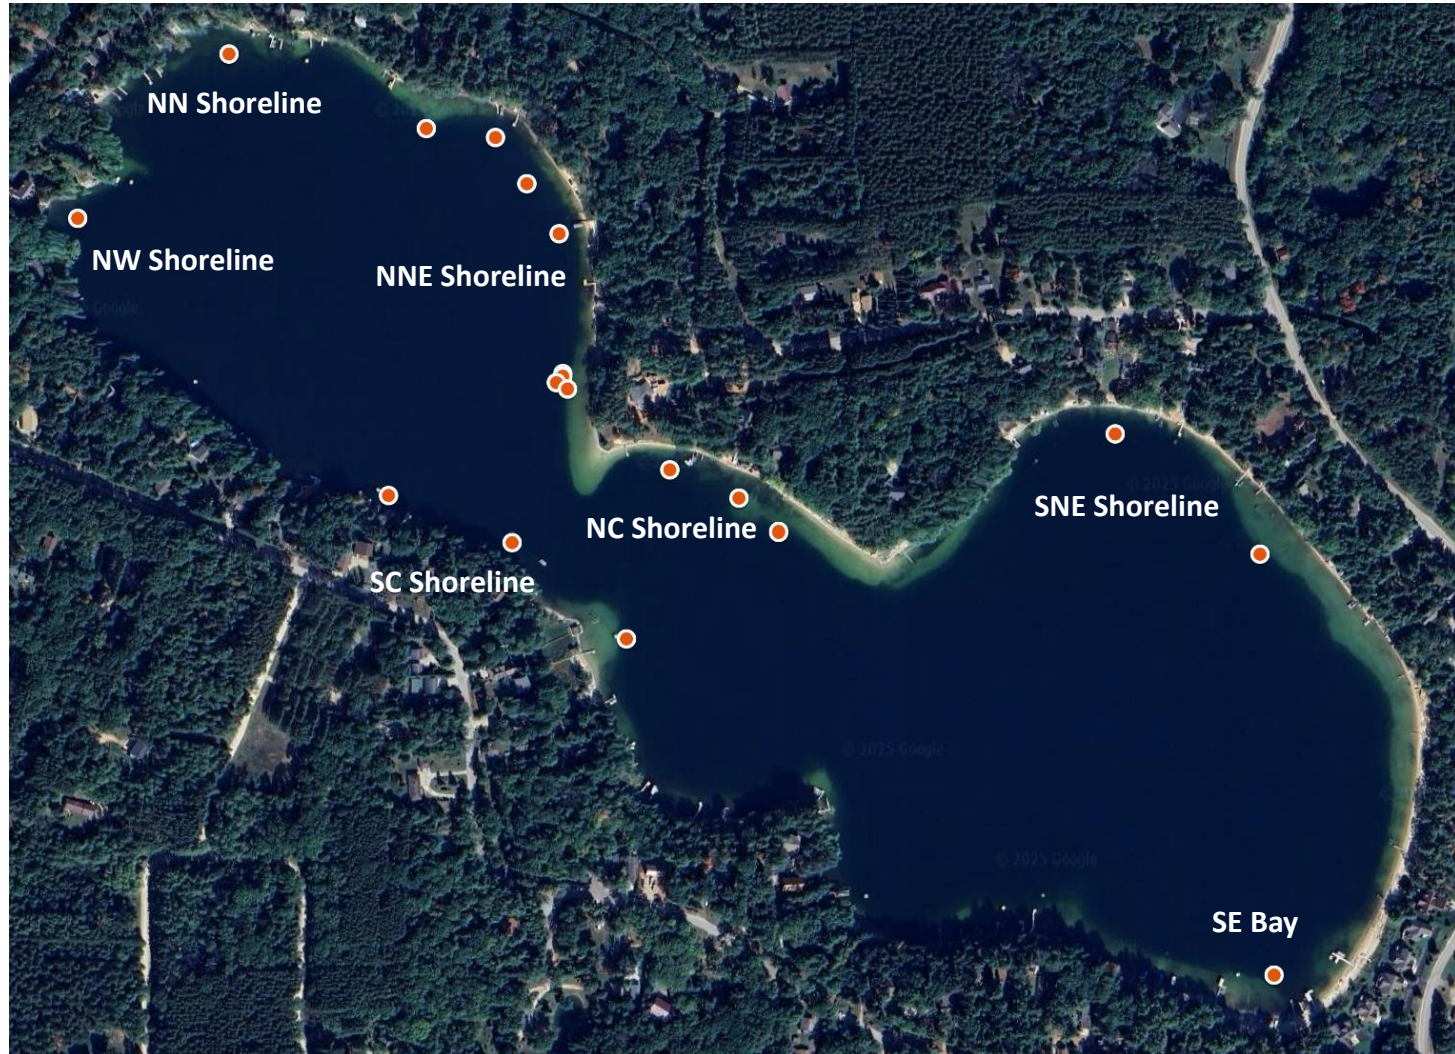
Map of Pearl Lake Dive Sites

Dive Highlights and Recommendations: The dive team spent the bulk of their time and found the most biomass along the Northeast Shoreline. At that site, the team discovered and harvested an unmarked small plant colony in ~20ft of water. In the SE Bay, the team found and removed some minimal curlyleaf pondweed in addition to the EWM. At the sites in the center of the lake the team discovered and removed additional unmapped clumps. Boat traffic was high in the center of the lake. Overall, Pearl Lake should continue to take an Integrated Pest Management (IPM) approach and evaluate different strategies to manage the EWM population on the lake. Continued monitoring and management efforts are important to prevent the spread of EWM throughout Pearl Lake.

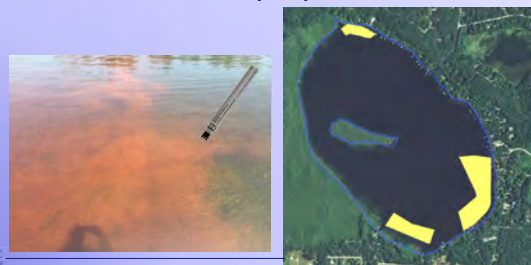
Herbicide Treatment on Loon Lake

- Tracer Dye (Rhodamine WT)
- ~24 acres of 305 acre lake (7.8%)
